# Manhole Inspection Summary

Manhole # S15AA1030MH

Insp Date: **3/15/07 11:29 AM**

**Location** Address: **2624 VIOLET AVE**

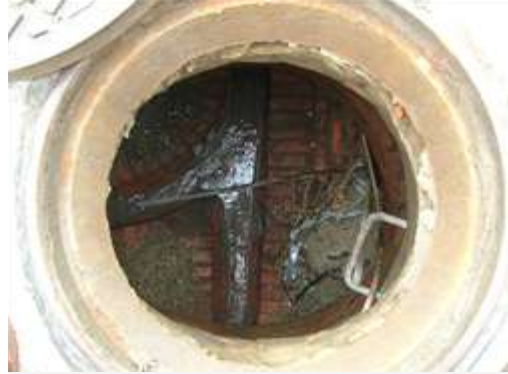
Top View

Evidence of surcharge - Bench debris.

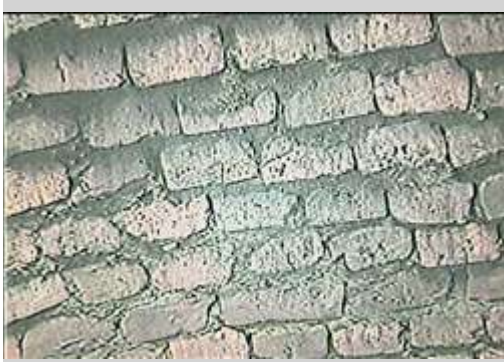
Defect

Barrel deterioration and infiltration.

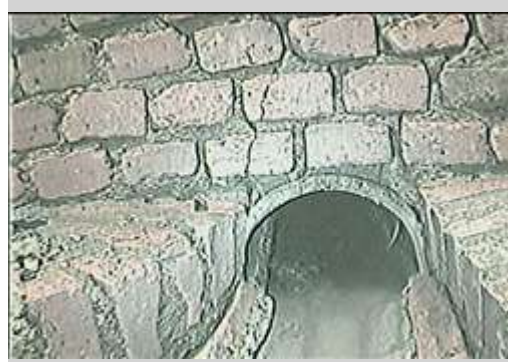
Defect

Barrel deterioration, cracks and infiltration. Channel deterioration.

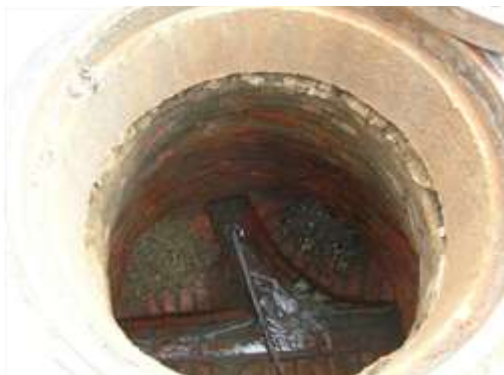
Defect

Frame leaks. Adjustment, Corbel and Barrel deterioration and infiltration. - other side.

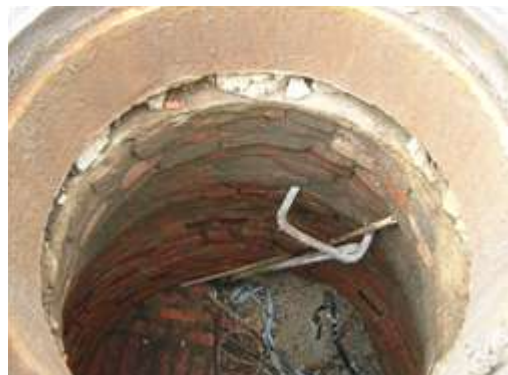
Defect

Frame leaks. Adjustment, Corbel and Barrel deterioration and infiltration.

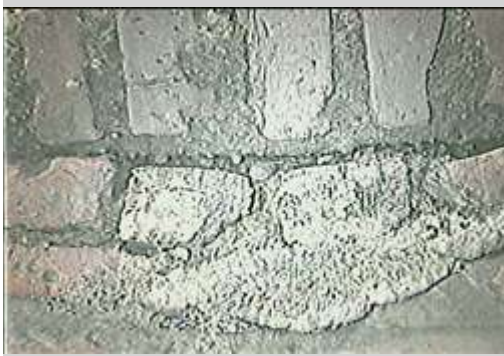
Defect

Channel deterioration.

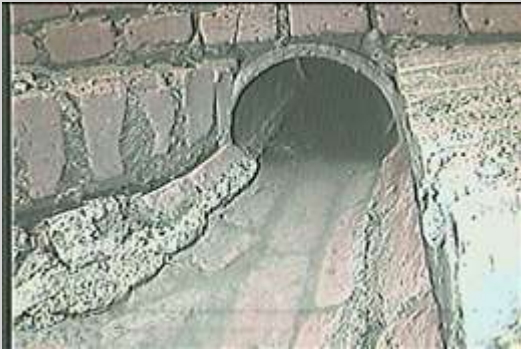
### 8 in. Circular Gravity Sewer Pipe Out @ 12 O'Clock

Barrel deterioration and infiltration. Channel deterioration.

Deposits: ☐ None ☐ Mud ☐ Sludge ☐ Debris ☒ Grease

Infiltration: **Evidence** Pipe Seal Cond: **Cracked**

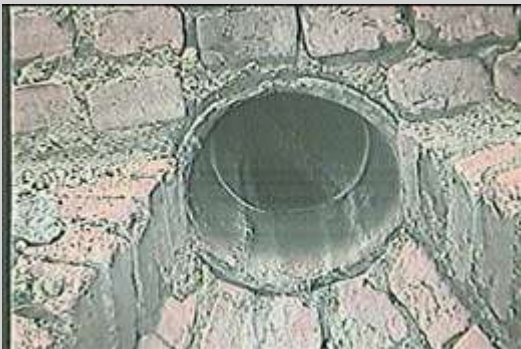
### 8 in. Circular Gravity Sewer Pipe In @ 6 O'Clock

Infiltration: **Evidence** Pipe Seal Cond: **Unknown**

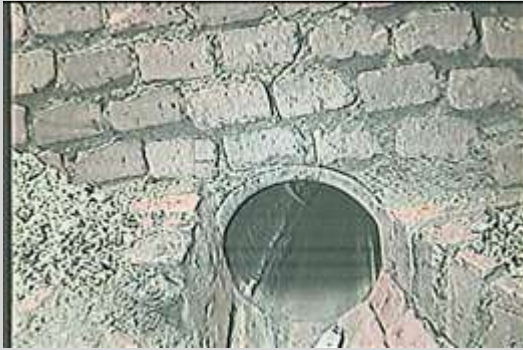
Pipe In @ 9 O'Clock

Infiltration: **Evidence**
